# METALLOSIS OF THE RESURFACED HIP

James W. Pritchett MD

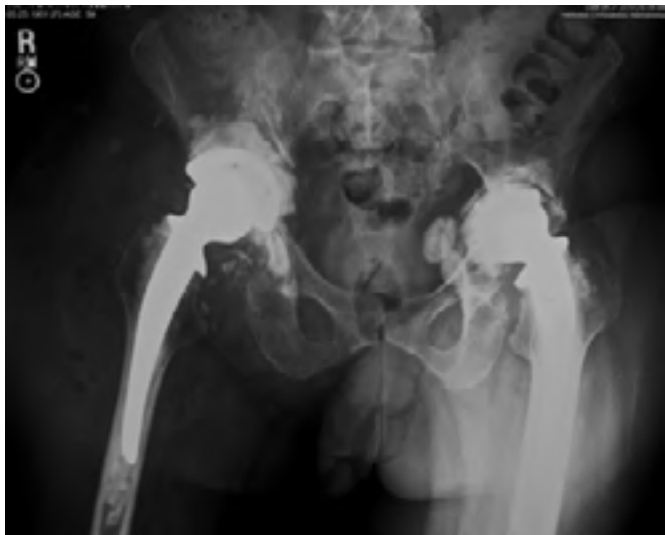
**Fig. 1** This anteroposterior pelvis radiograph shows a 58 year-old woman 40 years after receiving bilateral McKee-Farrar total hip replacements. On the left the original metal-on-metal prosthesis demonstrates acetabular loosening. On the right a revision using a custom made two-piece titanium and polyethylene acetabular prosthesis has been performed.

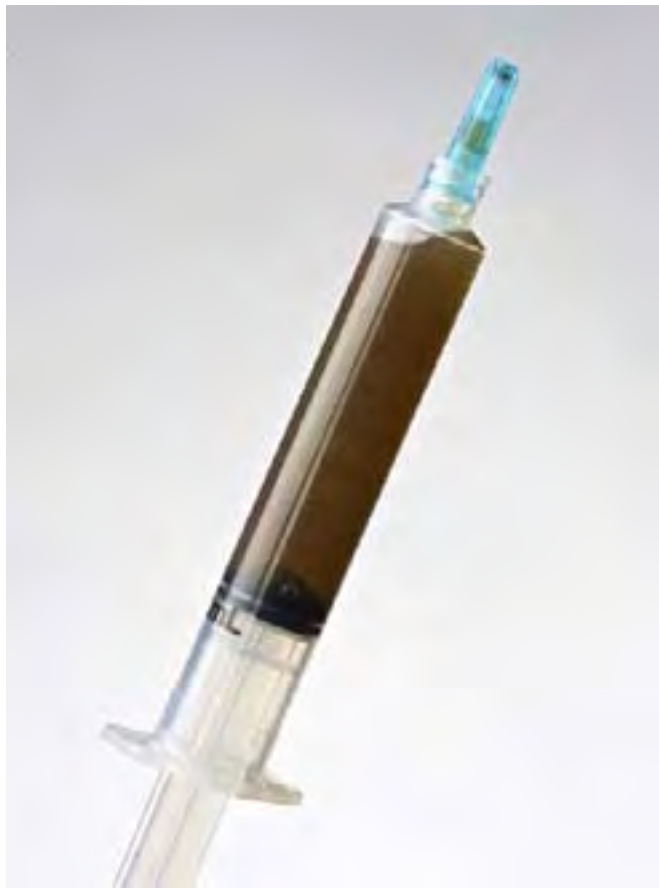
**Fig. 2** This syringe shows joint fluid that has been aspirated from a patient with metallosis 2 years following hip resurfacing surgery.

erally  $< 9 \mu\text{g/L}$ . Cobalt levels  $> 100 \mu\text{g/L}$  are found occasionally. Patients with equivocal levels should be followed over time with repeated testing. If the cobalt level is increasing, metallosis should be suspected. In some laboratories, testing of the joint fluid is possible but usually the appearance of the aspirated fluid is information enough to diagnosis metallosis (Fig 2).

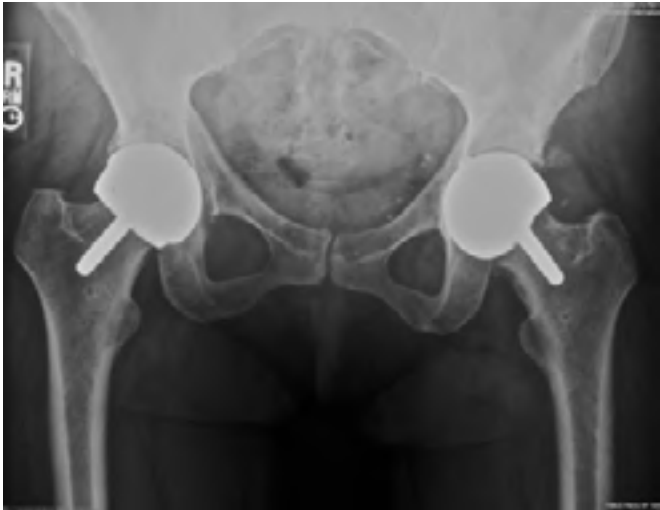
**Fig. 3** This anteroposterior radiograph shows a 46 year-old woman who has undergone bilateral hip resurfacing surgery using Birmingham prostheses. On the right the outcome is successful but on the left the hip is painful from failure of osteointegration and there is a lucent line around the acetabular prosthesis.

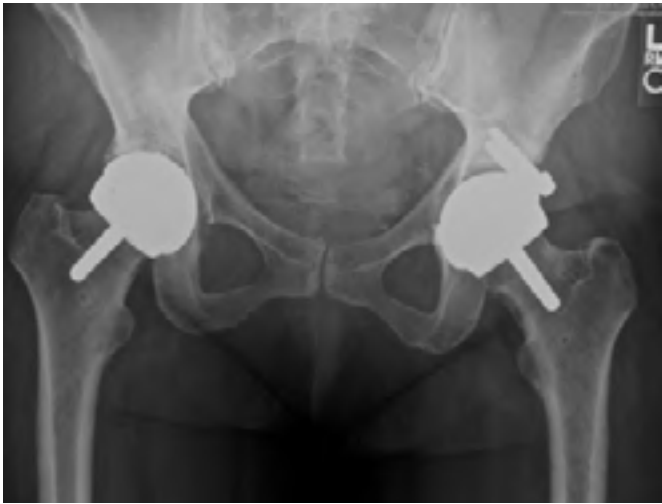
**Fig. 4** A revision of the left acetabular component has been performed using a dysplasia component with supplemental screw fixation.

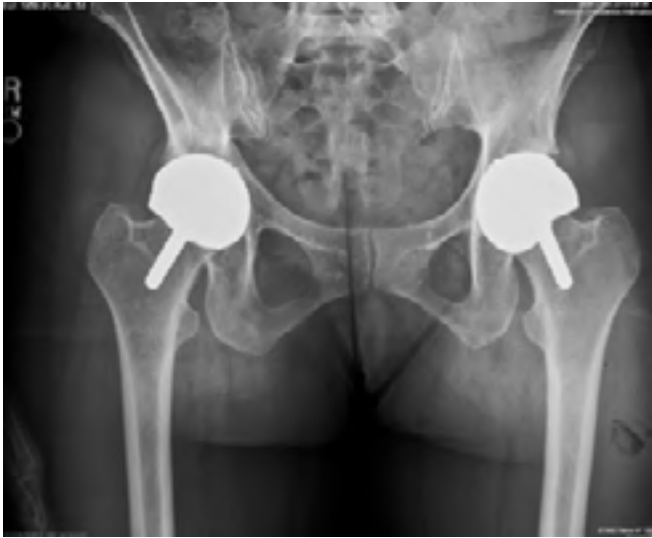
**Fig. 5** This anteroposterior radiograph shows a 45 year-old women who underwent bilateral hip resurfacing surgery for dysplasia. On the right the outcome was successful but on the left she developed metallosis and the acetabular component has a vertical orientation.

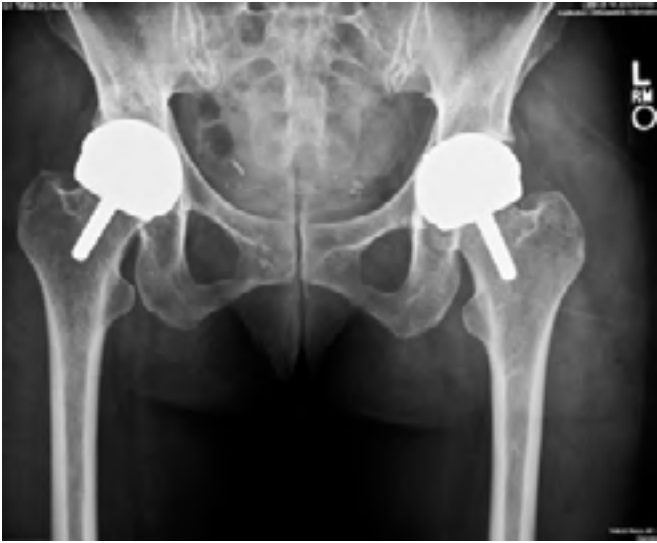
**Fig. 6** A revision of the left acetabular component to a more horizontal position has been performed and the outcome is successful.

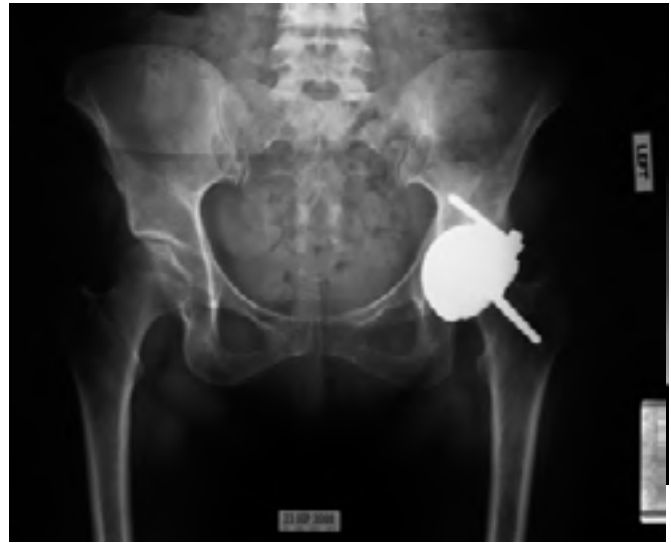
**Fig. 7** This anteroposterior radiograph shows the Conserve Plus dysplasia prosthesis that has been successfully used for revision surgery in this 44 year-old woman.

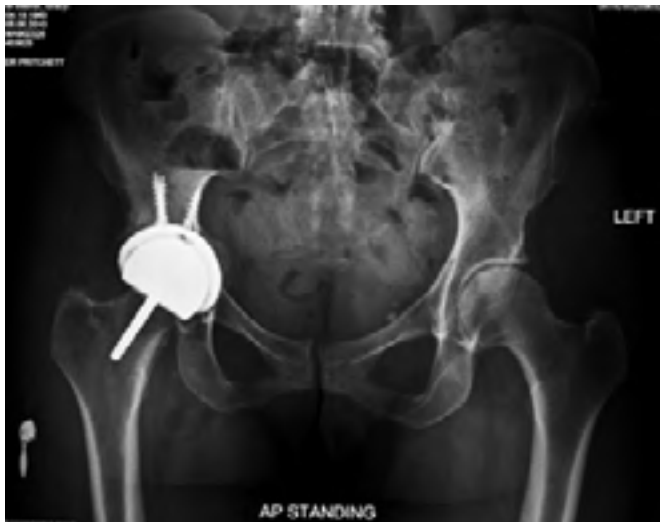
**Fig. 8** This anteroposterior radiograph shows a 51 year-old woman who underwent an acetabular revision of her resurfacing prosthesis using a two-piece titanium and polyethylene prosthesis.

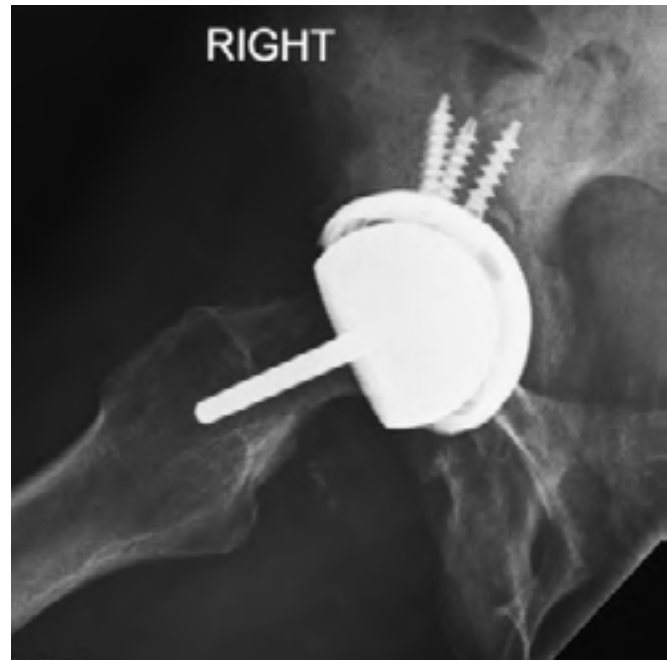
**Fig. 9** The lateral radiograph shows the availability of dome screw adjunctive fixation in the compromised acetabular bone.

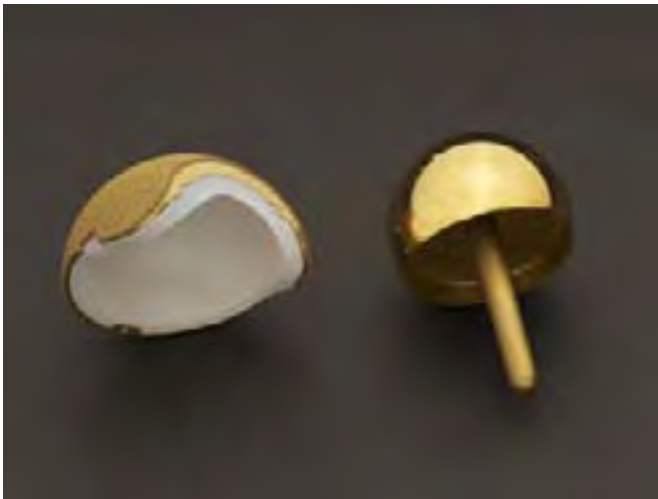
**Fig. 10** This photograph shows a currently available resurfacing prosthesis with a titanium backed polyethylene acetabular bearing surface as an alternative to metal-on-metal.
