Adverse reaction to metal debris: metallosis of the resurfaced hip

James W. Pritchett

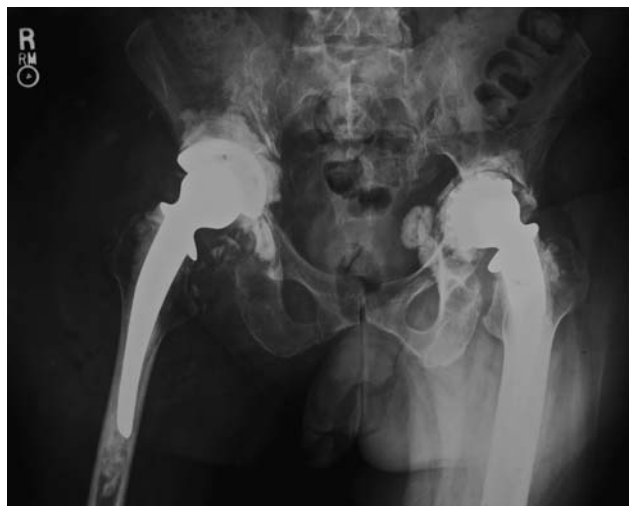
FIGURE 1. Anteroposterior radiograph of the pelvis in a 58-year-old woman 40 years after receiving bilateral McKee-Farrar total hip replacements. On the left, the original metal-on-metal prosthesis demonstrates acetabular loosening. On the right, a revision using a custom-made, two-piece titanium and polyethylene acetabular prosthesis has been performed.

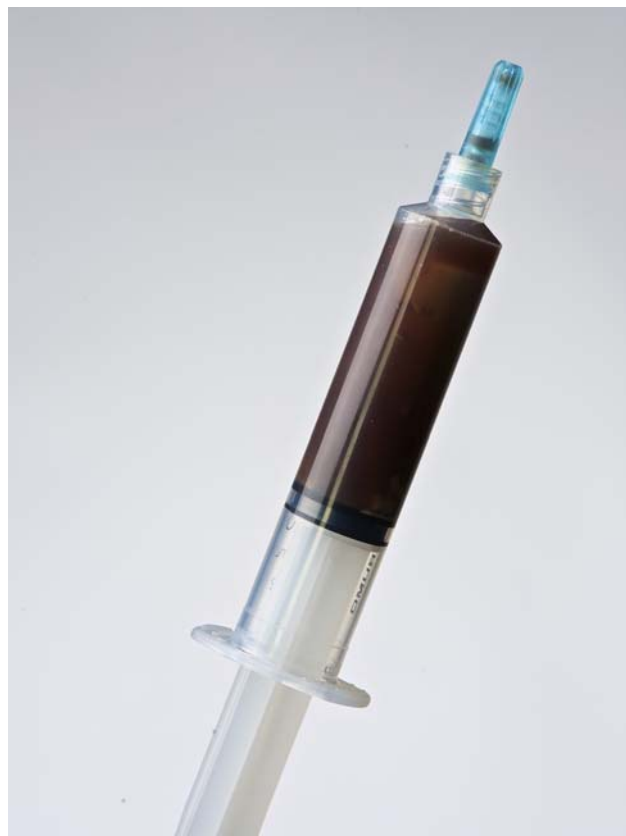
FIGURE 2. Syringe shows joint fluid that has been aspirated from a patient with metallosis 2 years after hip resurfacing surgery.

hair, blood, urine, vital organs and, if present, placenta.²¹ Thus, the cobalt level should be measured several months or a year after surgery to avoid a misleading result caused by the wearing-in process of the prosthesis.^{22,23} For unilateral metal-on-metal joint resurfacing, a cobalt level $\leq 4 \mu\text{g/L}$ can be expected and for bilateral resurfacing the cobalt level is generally $< 9 \mu\text{g/L}$. Cobalt levels $> 100 \mu\text{g/L}$ can be found occasionally. Patients with equivocal levels should be followed over time with repeated testing. If the cobalt level is increasing, metallosis should be suspected. In some laboratories, testing of the joint fluid is possible but usually the appearance of the aspirated fluid alone is diagnostic of metallosis (Figure 2).

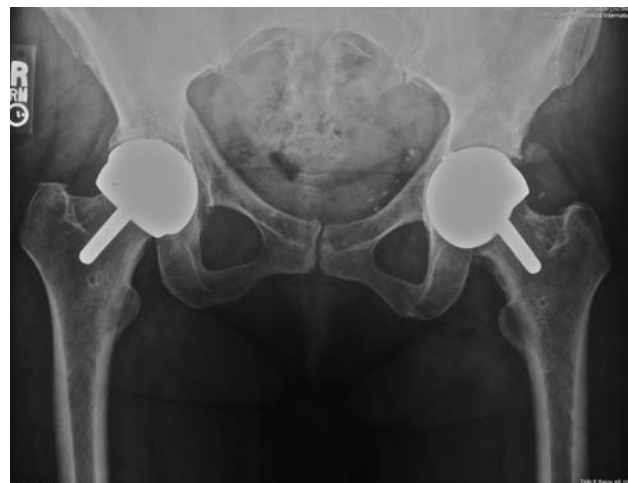
FIGURE 3. Anteroposterior radiograph of a 46-year-old woman who has undergone bilateral hip resurfacing surgery using Birmingham prostheses. On the right the outcome is successful but on the left, the hip is painful from failure of osseointegration, and there is a lucent line around the acetabular prosthesis.

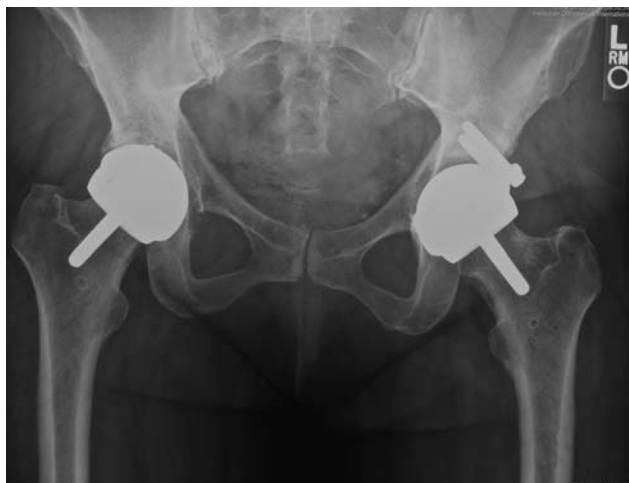
FIGURE 4. A revision of the left acetabular component has been performed using a dysplasia component with supplemental screw fixation.

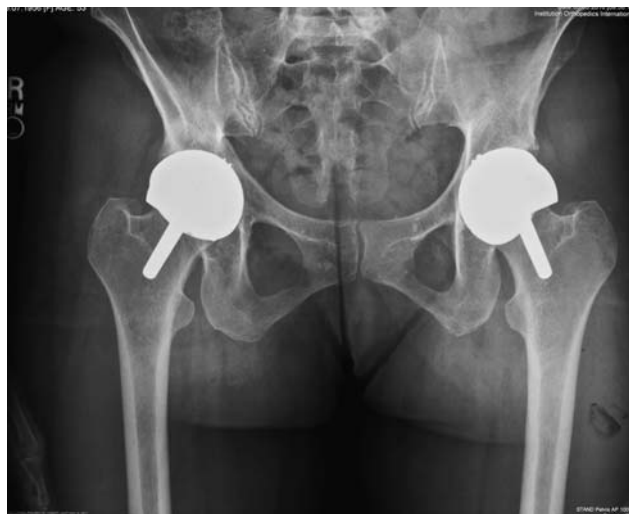
FIGURE 5. Anteroposterior radiograph of a 45-year-old woman who underwent bilateral hip resurfacing surgery for dysplasia. On the right the outcome was successful, but on the left she developed metallosis. The acetabular component has a vertical orientation.

The author performs most revision procedures with primary resurfacing components using the same component size (Figures 5 and 6). Outside diameters 2–4 mm larger also are available, if necessary, to achieve a secure press fit. Peripheral screws can be beneficial if additional fixation is necessary. The components provided for patients with dysplasia can be used for this purpose (Figure 4). Because of the potential for superior osseointegration, the author now uses a two-piece titanium backed with a cobalt insert for some revisions and certain difficult primary procedures (R3 Acetabular System, Smith & Nephew, Memphis, TN; Figure 7). In the author's experience with revision resurfacing, patients reported a shorter recovery interval than with the index procedure. For an experienced resurfacing revision surgeon, the procedure can be completed readily. The original position for the resurfacing is avoided, and a better position for the new acetabular component is more apparent. Often it is possible to see where the original component did not match the prepared bone. The original

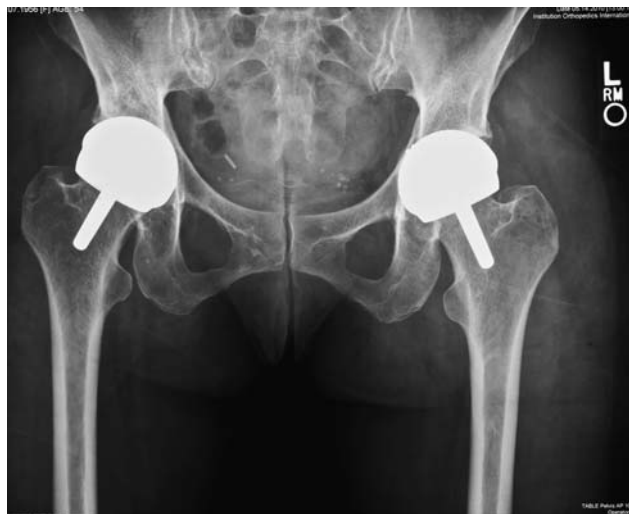
FIGURE 6. A revision of the left acetabular component of patient in Figure 5 to a more horizontal position was performed and the outcome was successful.

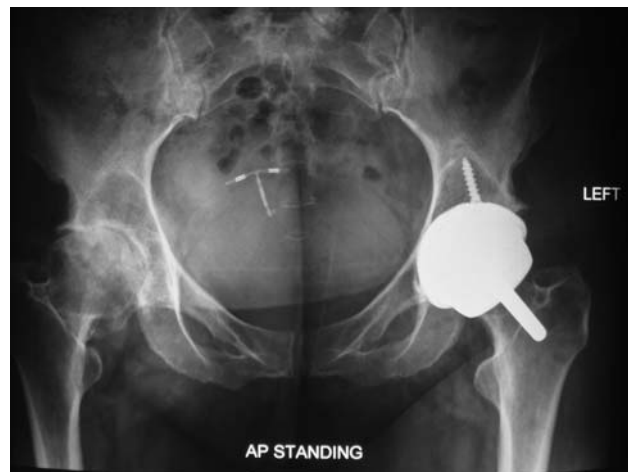
FIGURE 7. The R3 two-piece titanium-backed cobalt bearing prosthesis has been used to provide a successful revision of the hip resurfacing.

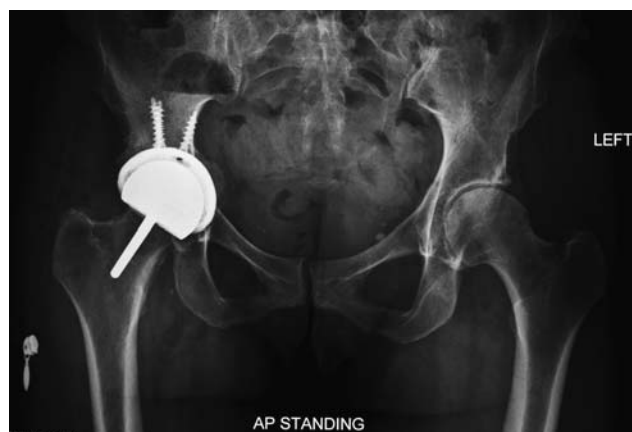
FIGURE 8. Anteroposterior radiograph of a 51-year-old woman who underwent an acetabular revision of her resurfacing prosthesis using a two-piece titanium and polyethylene prosthesis.

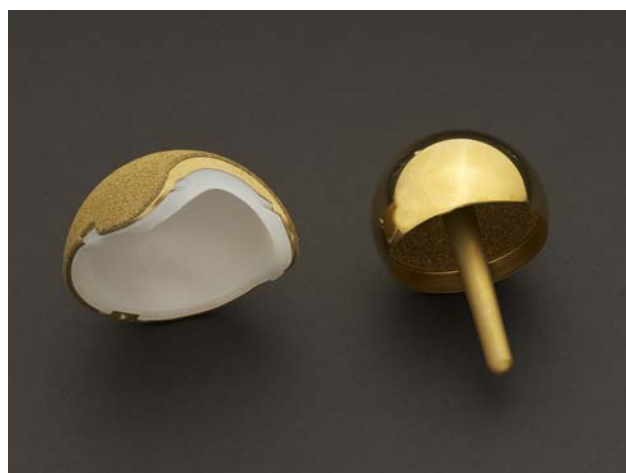
FIGURE 10. Photograph shows a currently available resurfacing prosthesis with a titanium-backed polyethylene acetabular-bearing surface as an alternative to metal-on-metal.

It is possible to perform hip resurfacing surgery using a nitrated titanium femoral prosthesis with a polyethylene acetabular component, but published long-term data with this option are not readily available (Figure 10). From 1995 until 2005, the author used a ceramic femoral prosthesis with a cemented polyethylene or two-piece metal-backed polyethylene acetabulum with satisfactory outcomes. The FDA reclassified the femoral device, and additional testing will be required for continued use.^{36,52}
