# Seroma and Osteolysis with BP Hip Resurfacing

James Pritchett MD

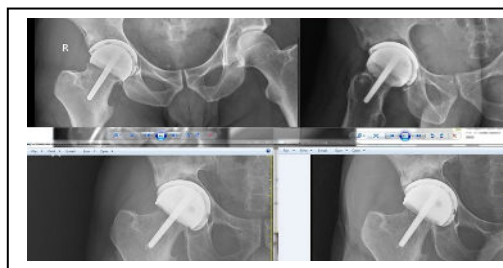
*Fig. 1. These radiographs show the progression of osteolysis around a BP HRA over 3 years in a very active 44-year-old man.*

Early investigators thought osteolysis was from cement breakdown that caused a foreign body reaction. As cement techniques improved or cement went away, osteolysis was more often associated with wear of the polyethylene-bearing surface [9]. Osteolysis can be silent and associated with a good clinical outcome. It can also progress rapidly and become painful (Fig 1.).

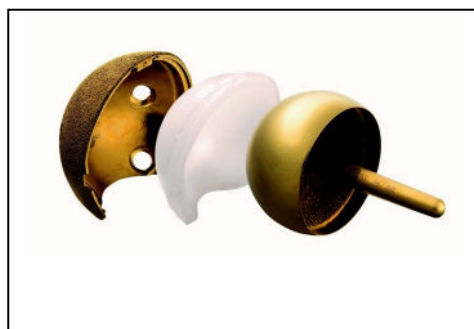
*Fig. 5. This is a photograph of the cementless titanium nitride-coated 3-part BP HRA from Endotec.*

Endotec continuously offered the current BP hip resurfacing as a 3-part FDA class II device starting in 1989 (Fig. 5).

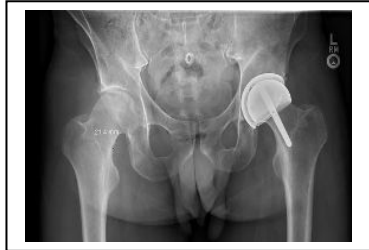
Fig. 6a. This AP pelvis radiograph shows a well-placed BP HRA in an active 40-year-old man.

Fig. 6b. This AP pelvis radiograph shows polyethylene wear and osteolysis 6 years later.

Fig. 6c. This AP pelvis radiograph shows the acetabular component has been removed and revised with screw fixation and bone grafting.

treated with bearing surface exchange and retention of the HRA acetabular shell with grafting through the holes in the shells (Figs. 6 and 7). The outcomes have been positive in 90% of revisions.

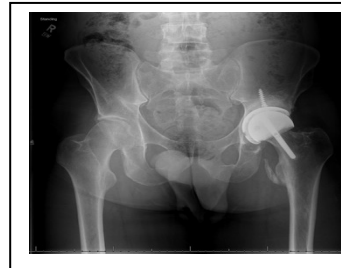
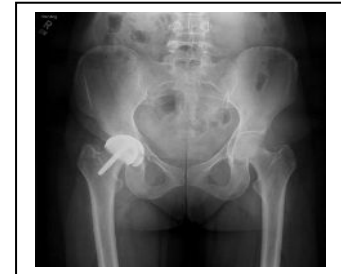
Fig 7a. This AP pelvis radiograph shows polyethylene wear and osteolysis 10 years after a BP HRA in a 37-year-old female athlete.

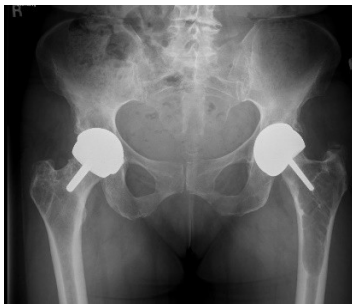
Fig 8. This AP Pelvis Radiograph shows a 65 year-old woman 20 years following a BHR on the Right and Conserve Plus on the left. There is severe femoral osteolysis on the left and significant acetabular stress shielding on the right.
