# REVISION HIP RESURFACING

James W. Pritchett MD

## Abstract

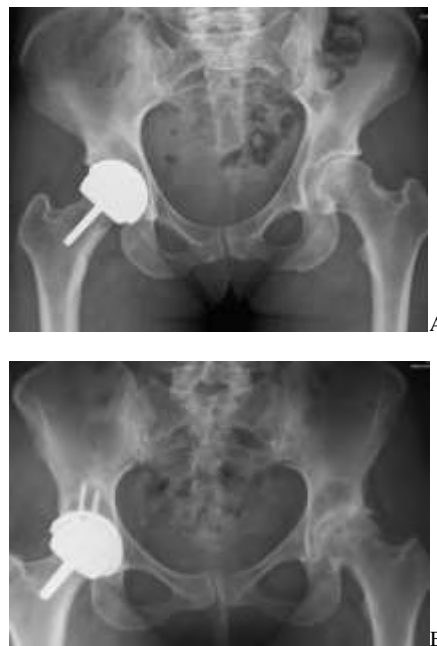
Fig. 2. A. This 40-year-old gymnastics instructor presented with an adverse reaction to metal wear debris 4 years after her Conserve Plus hip resurfacing. B. Her 46 mm (OD) metal acetabular component was revised to a two-piece titanium back cross-linked polyethylene implant that matched her 40 mm femur and she returned to gymnastics.

change the bearing surface to a polyethylene acetabular prosthesis. In certain instances of loosening or component malposition, a new metal component is placed (Figs. 2, 3).

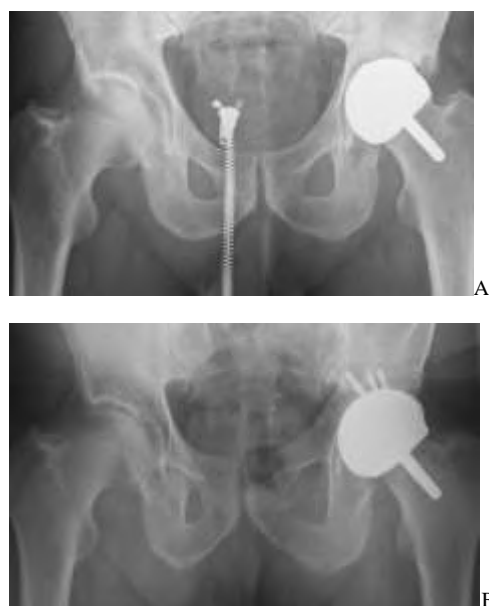
Fig. 3. A. A 44-year-old professional cyclist developed an adverse reaction to metal wear debris 5 years after his Birmingham Hip Resurfacing. B. A two-piece metal revision acetabular component was placed and he returned to professional cycling.

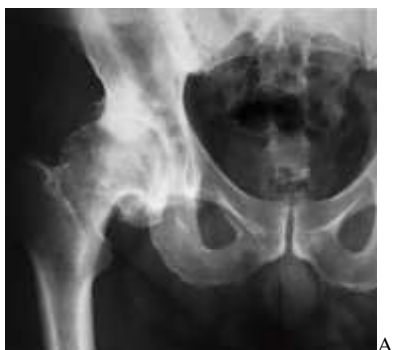
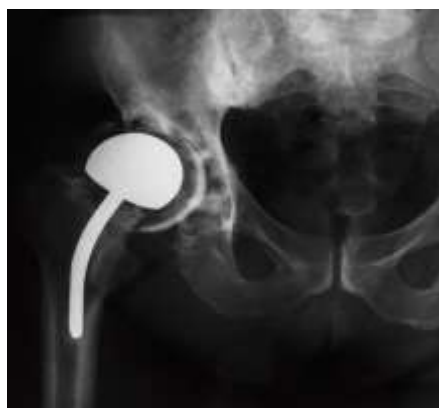
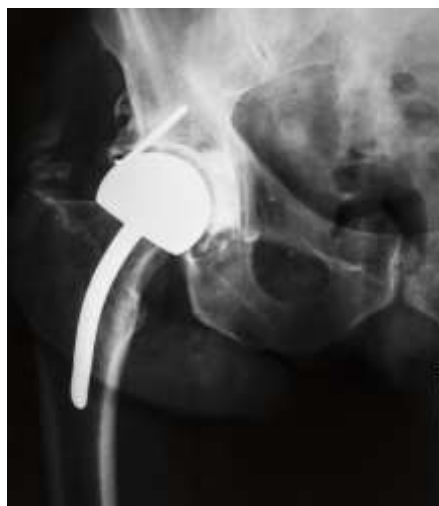
Fig. 4. A. This 41-year-old professional golfer presented with severe arthritis that prevented him from continuing his career. B. He was treated with hip resurfacing using an all polyethylene acetabular component and a curved-stem femur. He returned to professional golf and won an event. Ten years later his acetabular component loosened. C. He underwent revision surgery with another cemented all polyethylene acetabular component that had one fixation screw. He won a senior professional event.

Revision acetabular prostheses possibly with adjunctive screw fixation can be helpful. The results of single-component hip resurfacing revision for an adverse reaction to metal wear debris are favorable.<sup>19</sup> There were three re-revisions in 90 procedures. The average Harris Hip score following revision resurfacing was 93.5 (excellent) and the mean UCLA activity score was 7. These results compare favorably to primary resurfacing outcomes. Acetabular revision for polyethylene wear consists of a bearing surface only exchange. This has not been necessary with cross-linked polyethylene bearings as none has failed, but has been successful with prior implants using conventional polyethylene.<sup>1,7</sup> Revision of one-piece polyethylene resurfacing components consists of revision to a two-piece current-generation component. Revision for painful acetabular loosening is performed by placing a new acetabular component with adjunctive screw fixation, if needed (Fig. 4).

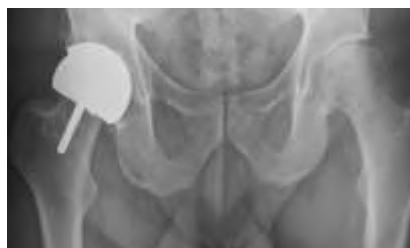
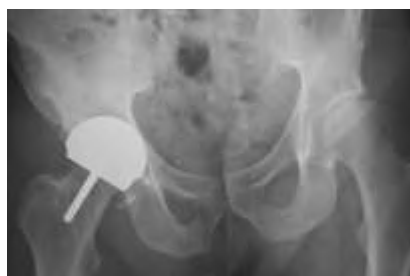
Fig. 5. A. A 37-year-old tennis professional presented with a loose Zimmer Durom metal-on-metal acetabular prosthesis. B. A revision metal acetabular prosthesis was placed and he returned to professional tennis.

The new implant can be metal (Fig. 5) or polyethylene (Fig. 6).

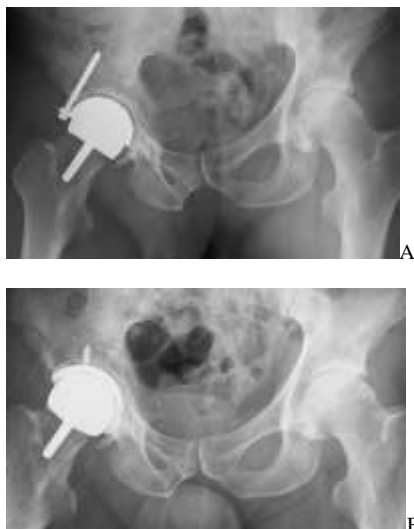
Fig. 6. A. A 55-year-old fire fighter presented with a loose metal acetabular prosthesis. The largest metal component that matched his femoral prosthesis was insecure despite screw fixation through the Birmingham dysplasia socket. B. A revision two-piece polyethylene component was 5 mm larger externally but matched his femur. Subsequently, he was able to return to full duty.

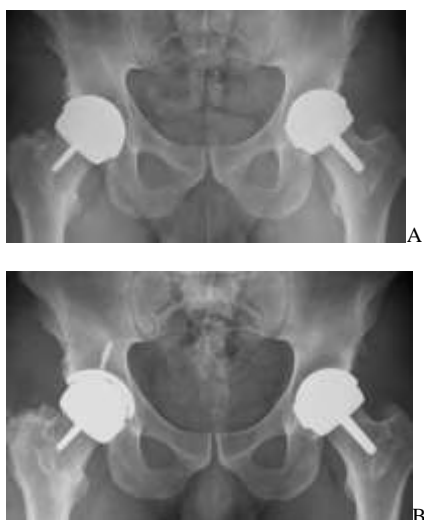
Fig. 7. A. This 31-year-old man who competes in martial arts presented with an adverse reaction to metal wear debris 4 years following his DePuy ASR right hip resurfacing. B. Because the ASR prosthesis was recalled and no compatible metal component was

possible, a matching two-piece metal/polyethylene acetabular revision was performed. He returned to competition.

If the manufacturer of the metal component no longer provides implants (e.g., ASR, Durom), revision to polyethylene is necessary (Fig. 7).

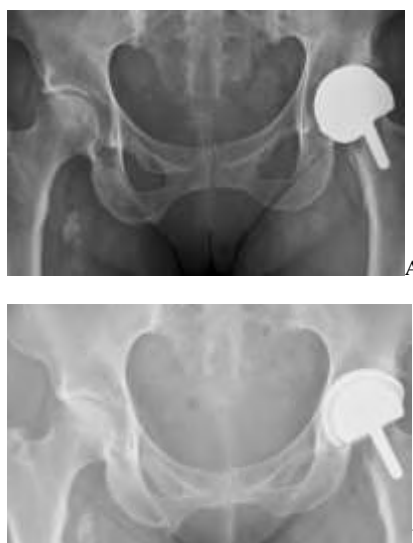
Fig. 8. A. This 49-year-old woman teaches Pilates. There was anterior/inferior impingement on her psoas tendon following metal-on-metal hip resurfacing with signs of an adverse reaction to metal wear debris. She was unable to continue teaching. B. Revision to a two-piece metal/polyethylene acetabular component allowed her to teach again and she also began teaching yoga.

If the manufacturer still provides implants (Birmingham, Biomet), another metal implant can be used. The Conserve is available outside the United States. There is an occasional need for acetabular revision for unfavorable component position. Patients may present with painful hip impingement that does not improve over a much extended interval or, very rarely, recurrent dislocation (Fig. 8).

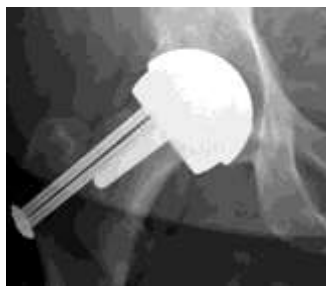
Fig. 9. This 35-year-old man is a trail rider who presented with a nondisplaced femoral neck fracture. This was treated by internal fixation using screws (courtesy film).

internal fixation of a nondisplaced femoral neck fracture can result in uneventful healing (Fig. 9).

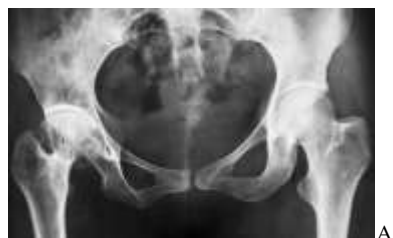
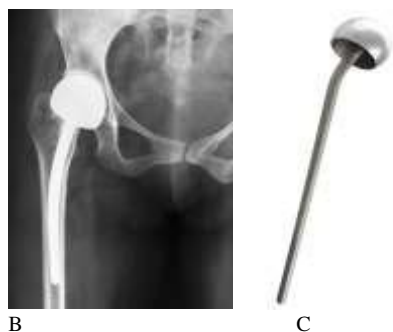
Fig. 10. A. This 36-year-old woman was extremely active teaching cross fit. She had groin pain and her bone scan showed increased uptake of labeled phosphorus in her very thin femoral neck. There was no arthritis in the joint so the diagnosis was a chronic femoral neck stress reaction. B. A long-stem femoral resurfacing prosthesis was placed matching her natural femoral head size. Her pain was relieved and no arthritis has developed over 20 years. C. This is a photograph of a long-stem resurfacing prosthesis that has also been used for certain revision procedures.

Typically, a femoral neck fracture with or without a resurfacing prosthesis in place will not heal and prosthetic replacement is needed. Loosening of the femoral component can be treated by revising the femoral resurfacing prosthesis or placing an intramedullary stem-supported femoral prosthesis. Custom long-stem resurfacing prostheses for difficult femoral geometry are used when necessary (Fig. 10).

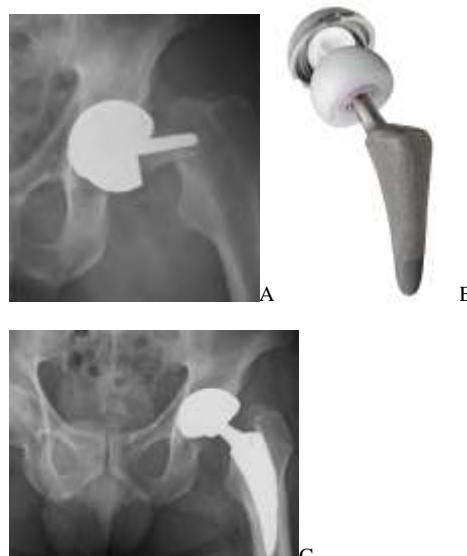
Fig. 11. A. This 48-year-old man works in a warehouse and presented with an acute femoral neck fracture several years following metal-on-metal Birmingham hip resurfacing. B. This is photograph of a dual mobility prosthesis that can be matched to a metal acetabular resurfacing prosthesis. C. The radiograph shows the 28 mm ceramic femoral head of the dual mobility (the cross-linked polyethylene to match the acetabular prosthesis of 52 mm is not visible).

It the metal acetabulum is well fixed and well positioned, revision for femoral failure is performed by femoral component revision only. The goal is to match the retained acetabular prosthesis with a polyethylene femur. This will maintain the joint stability and is the least intrusive revision option. A dual mobility prosthesis is used (Fig. 11). These prostheses place a 28 mm ceramic femoral prosthesis on any suitable stem and then a second femoral head of polyethylene is placed over the ceramic via a snap fit.

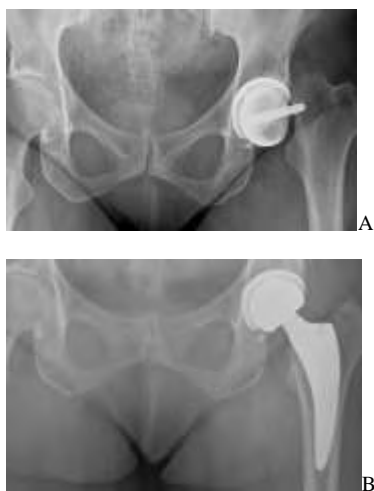
Fig 12. This 56-year-old woman is a runner and she received a polyethylene resurfacing procedure that allowed her to keep running. A. She sustained a femoral neck fracture. B. A ceramic femoral head that matched her acetabular component was placed on a stem-supported femoral prosthesis. She returned to running again.

If there is a femoral failure with a polyethylene acetabular component, the femoral component can be revised with or without touching the acetabular component.<sup>8,19</sup> If the polyethylene quality is good and not worn it is retained and a matching femoral prosthesis is used (Fig. 12).<sup>21,23</sup>

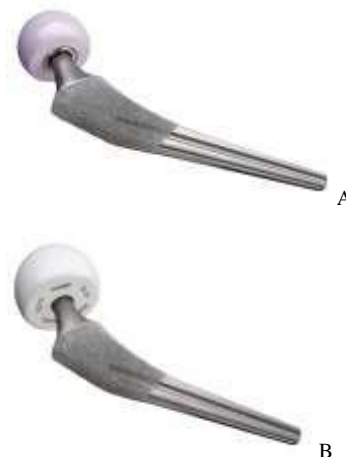
Fig. 13. These ceramic femoral head prostheses are appropriate for use on a stemmed femoral implant. A. The femoral head is a BioloX delta that is available in even-numbered millimeter sizes. B. This femoral head is a magnesium-stabilized zirconia and it is available in odd-numbered millimeter sizes. It comes as a full hemisphere, which is preferred over smaller and less stable conventional total hip femoral head components.

This is usually ceramic and any femoral stem can be used. A fully hemispherical femoral head rather than a hollow head with a stem is now used. Ceramic heads come in all available sizes from either CeramTec North America (BioloX®delta)

(Laurens, SC) or BioPro® Inc., (Port Huron, MI) (magnesium stabilized zirconium) (Fig. 13).

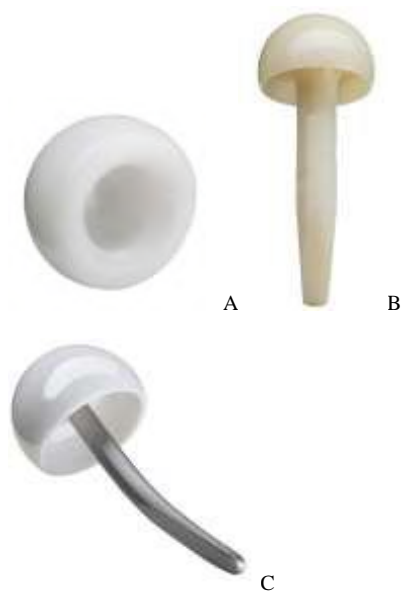
Fig. 14. A. This is cross-linked polyethylene and can be directly applied as a femoral component to the femoral neck or used with a small stem as a resurfacing prosthesis. B. This polymer-stemmed prosthesis prototype can be produced in variable stem lengths and thicknesses for direct use as a femoral component with a metal acetabular component. C. This modular stemmed entirely ceramic

femoral prosthesis can be used with a polyethylene acetabular prosthesis.

New resurfacing options for both primary and revision indications are under development. With the improved polyethylenes and ceramics now available, we will be able use polyethylene or ceramic femoral resurfacing components (Fig. 14) in addition to metal.
